Minutes
Farmington High School Facility and Financial Ad Hoc Committee
August 21, 2018

**CODE ANALYSIS AND
BUILDINGS & GROUNDS SURVEY**

FACILITY & FINANCIAL AD HOC COMMITTEE MEETING PRESENTATION

FARMINGTON HIGH SCHOOL FACILITY REVIEW January, 2015

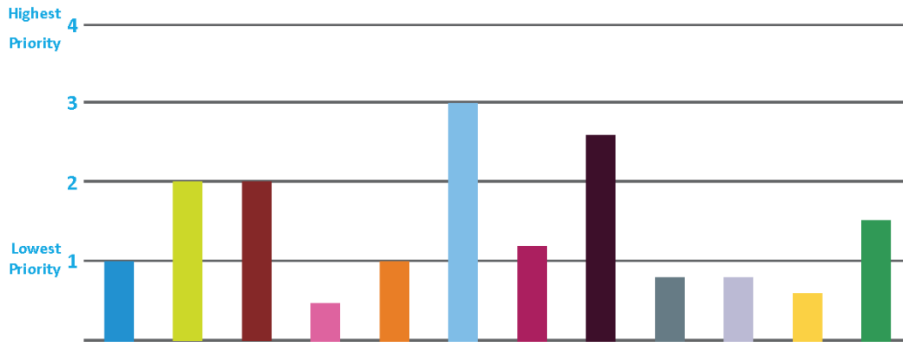
Prioritization of Required Work

UNION ELEMENTARY

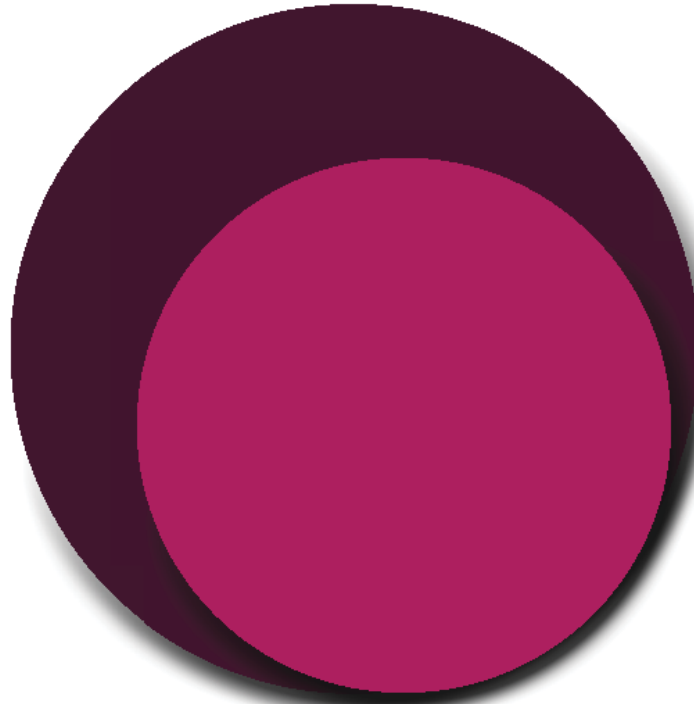
Survey Estimate ■ \$9,573,937
Renovate Like New ■ \$12,336,500
Project

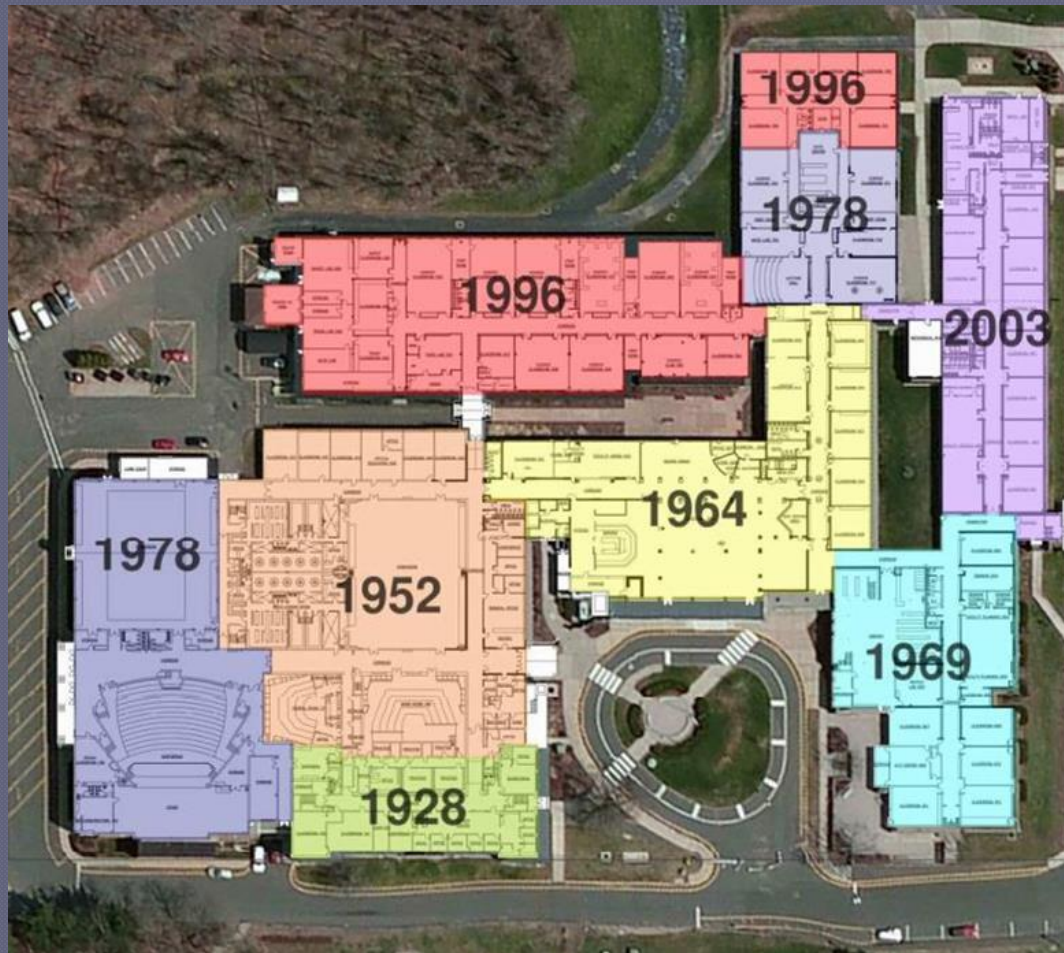
Renovations 1952-2003

- Built in 1928 with renovations occurring in 1952, 1964, 1969, 1974, 1978, 1996, and 2003
- During 2014-2015 budget approval process, a recommendation was made to take a comprehensive look at Farmington High School
- Multiple renovations due to enrollment created a sprawling facility (See OCR and NEASC Reports)
- ADA non-compliance (See OCR Report)
- Facility limiting educational programming (need for more learning space)
- Facility drives schedule and impacts programming and opportunities (undersized cafeteria, library, learning commons areas, etc.)
- Pervasive issues with student and faculty comfort (heating and cooling)
- Limited Air Conditioning (facility used as an emergency shelter for the Town of Farmington)
- TECTON conducted this review

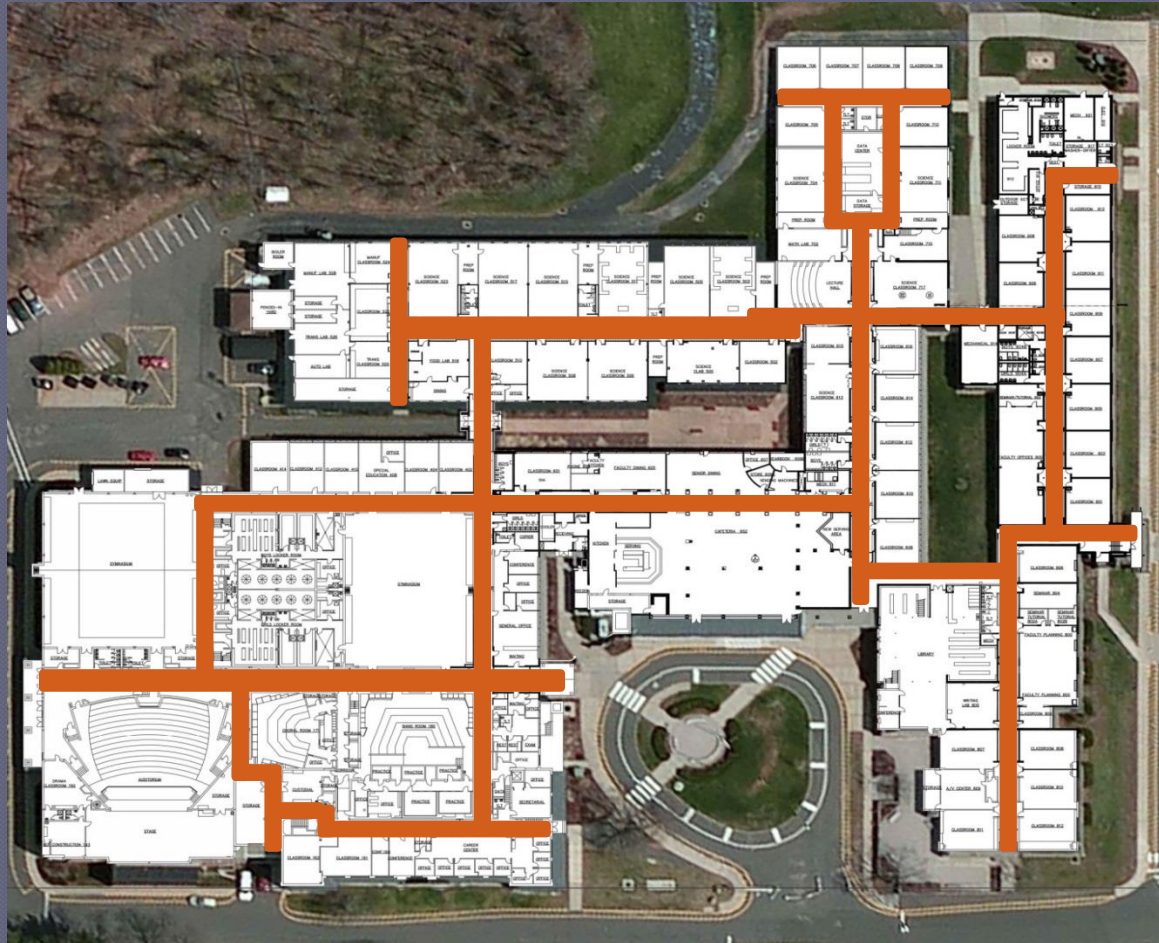
SPRAWLING BUILDING

- **Facility Sprawl** Several additions since 1952 creating sprawling building, 30% “unused” hallway space, and crowded hallways (need to use circle to get students to class on time), and lack of space to add educational programming. The additions have primarily addressed enrollment increases, but have resulted in a very large, inefficient facility footprint impacting not only energy costs, but security, insufficient student classroom space, a need for students to travel outside the building to travel to classes (696 student cross intersection between classes 9 times per day and 1070 feet from one side of the building to another), significant hallway congestion, inadequate use of space (30% unused space), a lack of space for robotics, lack of space for whole school staff professional learning and collaboration as well as constraints on educational programming for students (FHS Statement of Need)

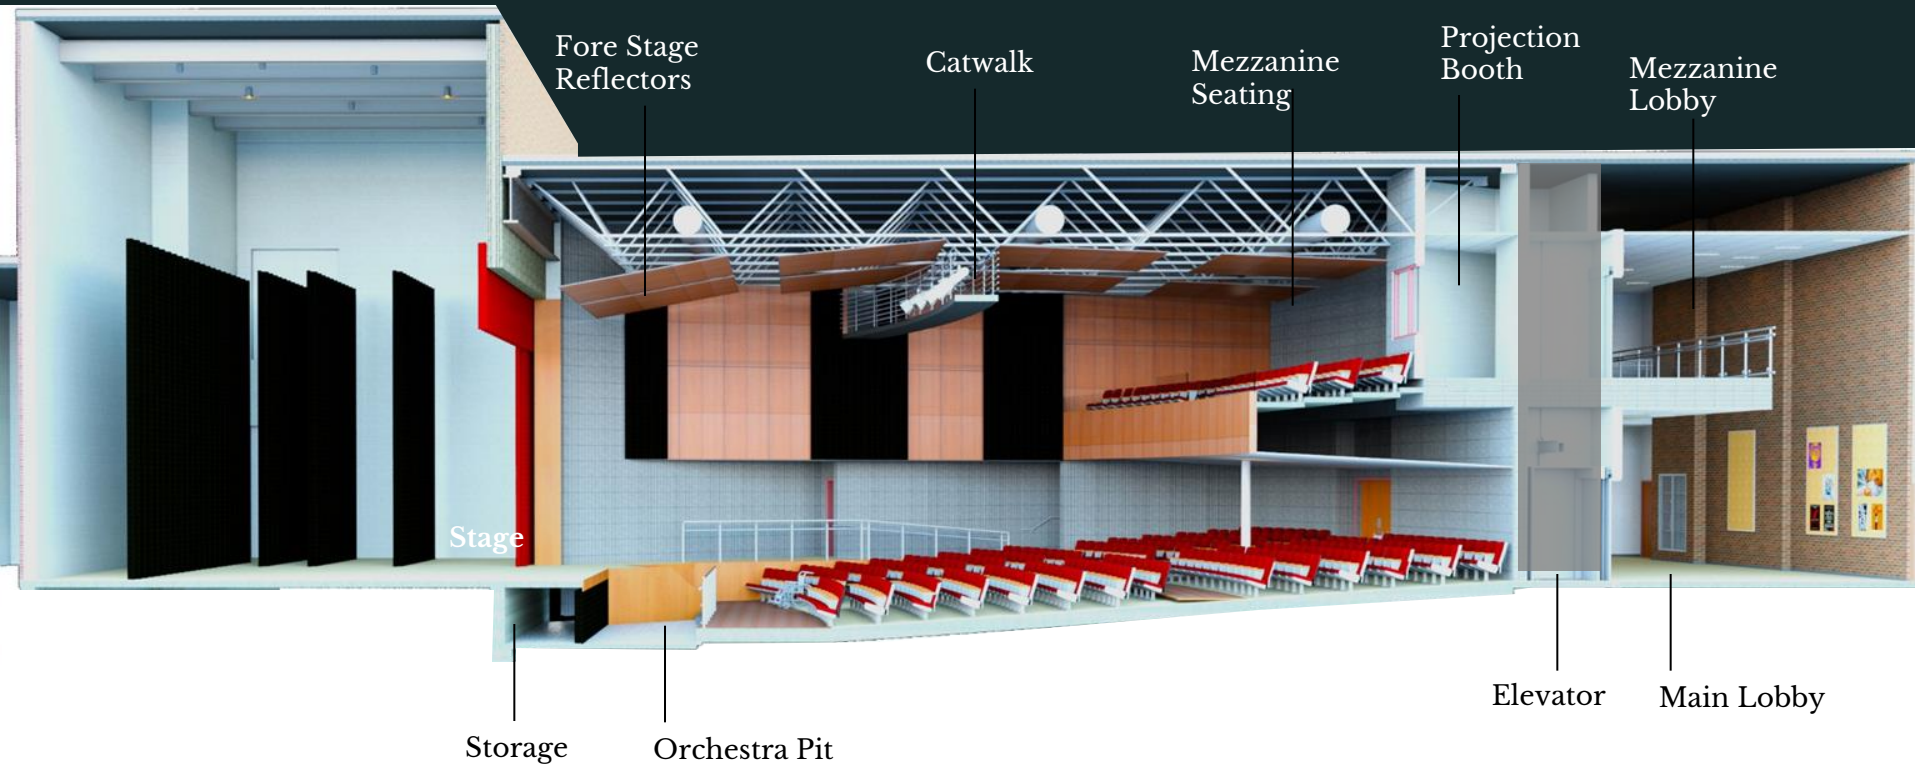
PROPOSED AUDITORIUM DESIGN – SECTIONAL VIEW

- Acoustics Short Reverberation Time
- Absorptive Rear Wall
- Side Wall Configuration
- Sound & Light Lock at Doors
- Absorptive Ceiling Materials
- Projection Booth HC Accessibility
- Projection Booth Acoustical Separation
- Mechanical Systems Noise
- Proscenium Height
- Condition of Seating

- Reverberation time is too short to support
- Fanned walls impact performances
- Box in fanned walls
- Raise proscenium height
- Inadequate stage shelf needs upgrading
- Loud mechanical system requires upgrading
- Add retractable curtains (front of sidewall boxes)
- Add rear wall absorption
- Add hand reflectors on ceiling

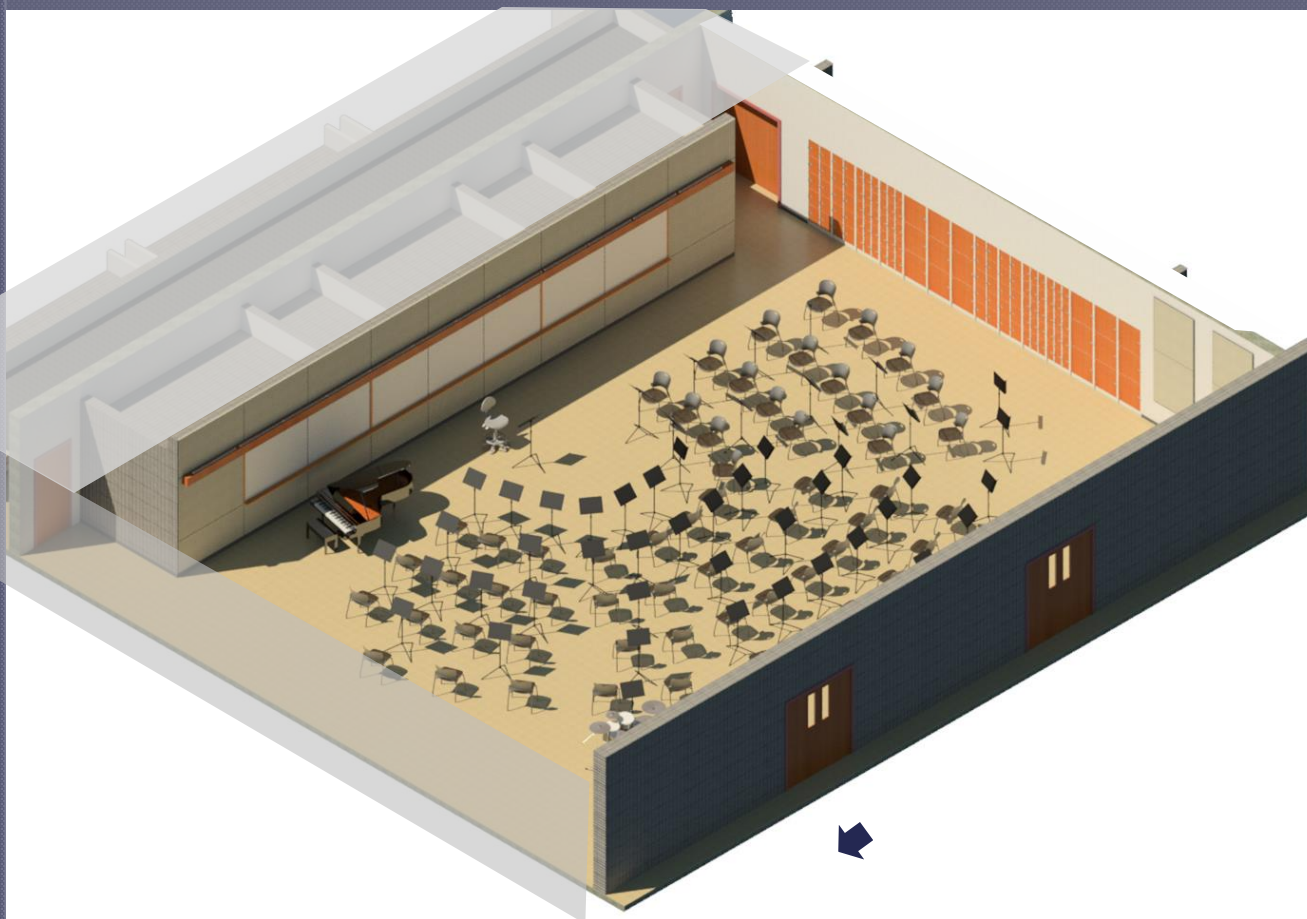
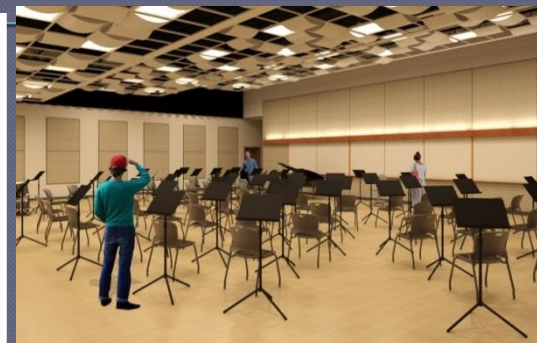
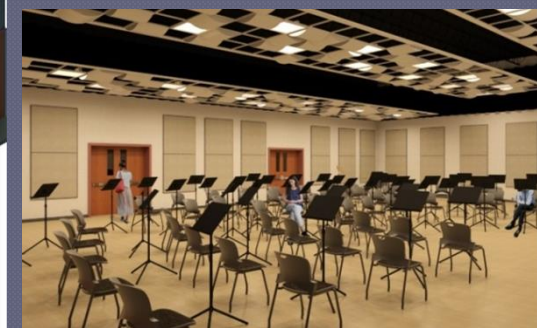
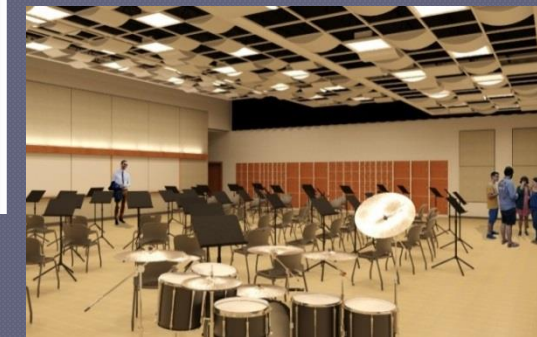
PROPOSED DESIGN – BAND REHEARSAL ROOM

1. Meet Code & Accessibility
2. Acoustics Addressed
3. Efficient Instrument Storage
4. Increased Usable Instructional Area

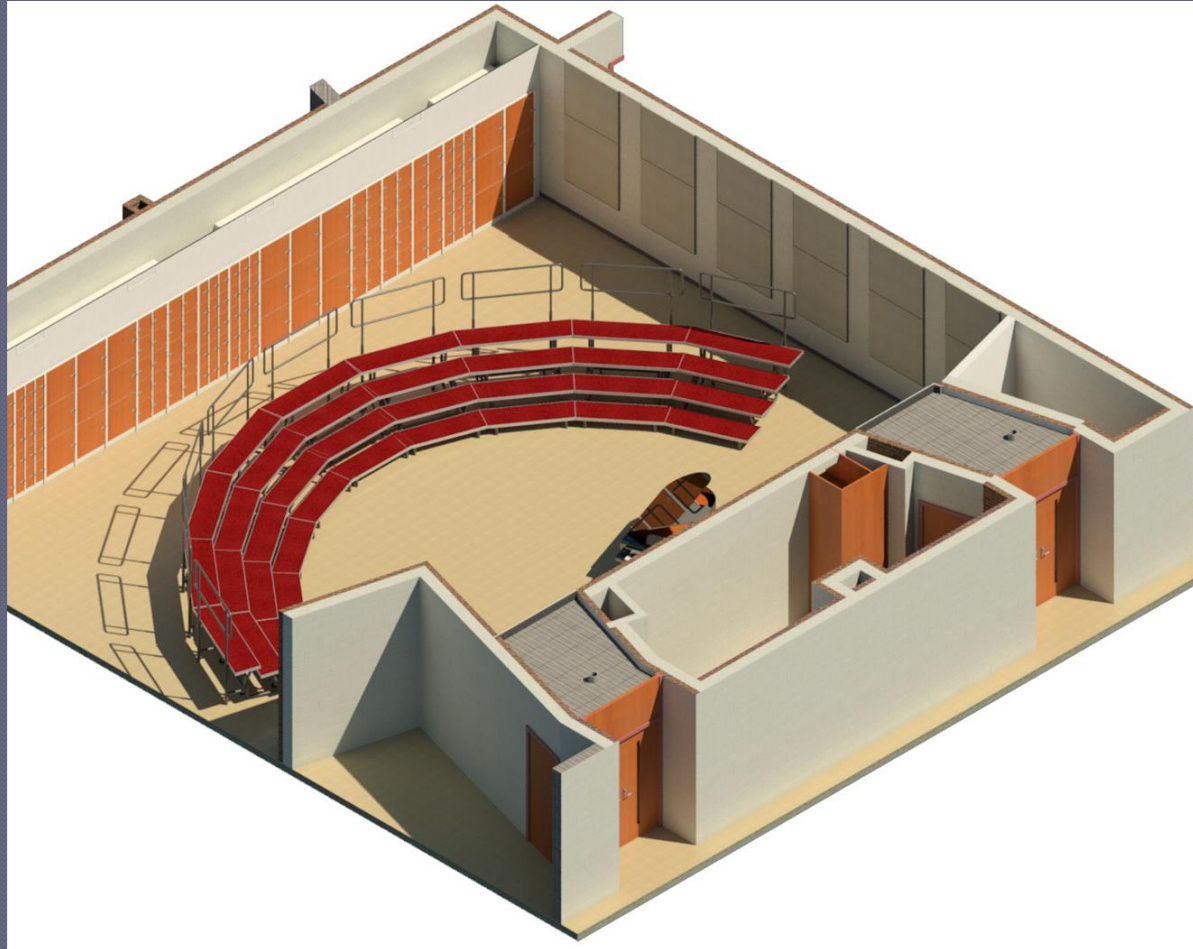
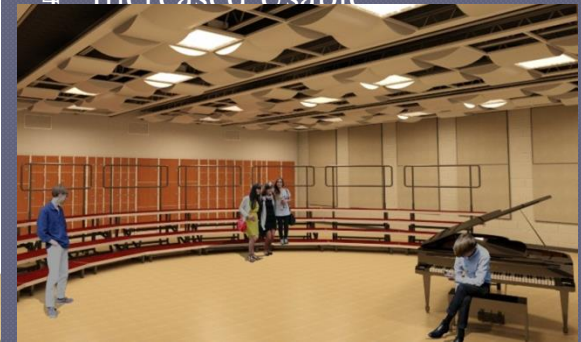
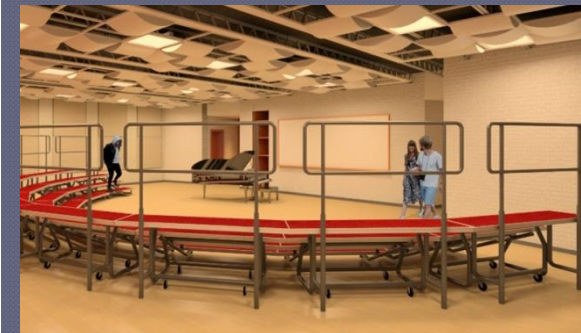
PROPOSED DESIGN – CHORUS REHEARSAL ROOM

1. Meet Code & Accessibility
2. Acoustics Addressed
3. Efficient Instrument Storage
4. Increased Usable
